## Spring Thaw and Beavers Are No Match for Tensar<sup>®</sup> InterAx<sup>®</sup> Geogrid

### Trent Hills 13th Line East

Trent Hills, ON

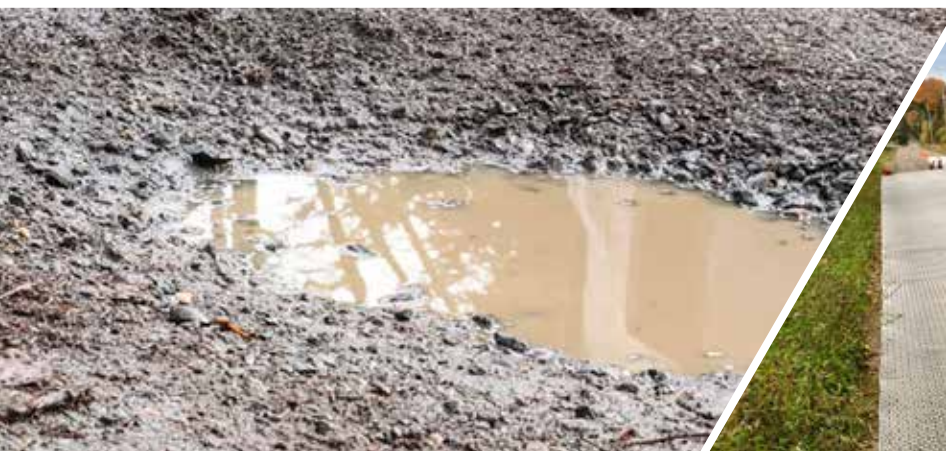
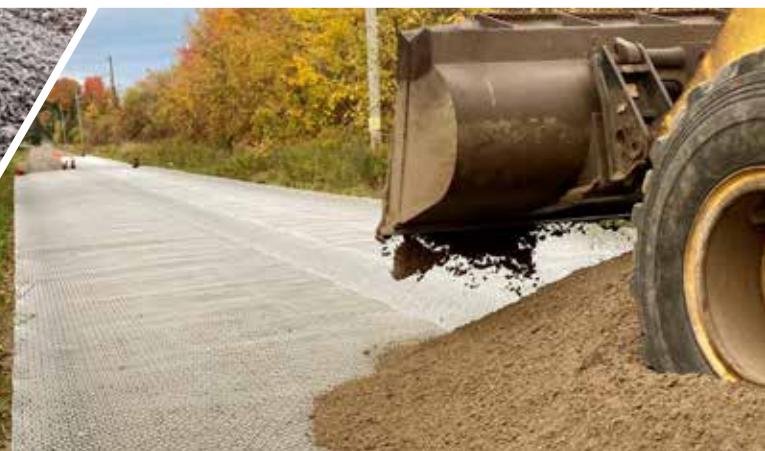
This section of road was always soft and wet when the frost came out of the ground. But this year, there was an added problem of beavers. Beavers built a dam on the adjacent property causing the area to flood. The high-water level combined with the spring thaw caused the road to blow apart. Local residents, buses and garbage trucks were practically blocked from passing through this section of road.

At the request of the Municipal Roads Supervisor, Tensar visited the site and carried out Dynamic Cone Penetrometer (DCP) testing to assess the soil strength. A recommendation was made to use InterAx NX850 with 200 mm of fresh gravel.

The owner was able to rebuild this section of road adding structure to bridge over the underlying soft soils without excavating deeper and building a thicker section. They saved 45% in cost, 70% in construction time and 61% in carbon use. Although the beaver dam was removed, this road is ready to handle them if they ever return.
