CASE STUDY

CENTRALIA AIRPORT

EXTER, ONTARIO, CANADA

AN OVERVIEW OF 30 YEARS OF SERVICE:

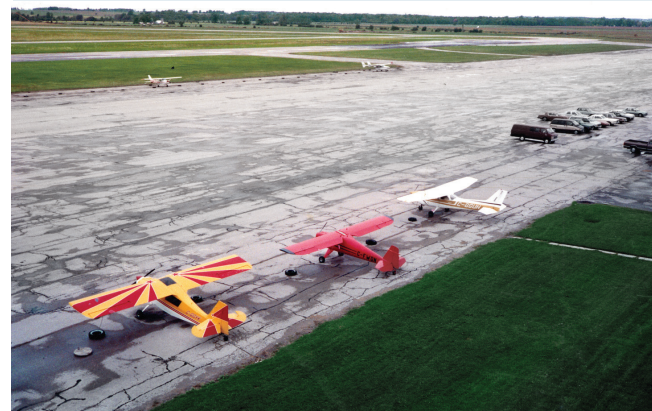
Severe cracking of the airport apron in 1992 at the Centralia Airport was likely to affect aircraft movement and safety.

A combination of irregular maintenance and harsh weather was causing serious cracking of the airport's paved surfaces. The airport apron was becoming extremely oxidized and brittle due to the harsh climate. Centralia's highest recorded monthly average temperature was 80°F in July while the lowest was 15°F in January. The surface layer included thermal, alligator, transverse and longitudinal cracks. Further surface degradation was likely to affect aircraft movement and safety.

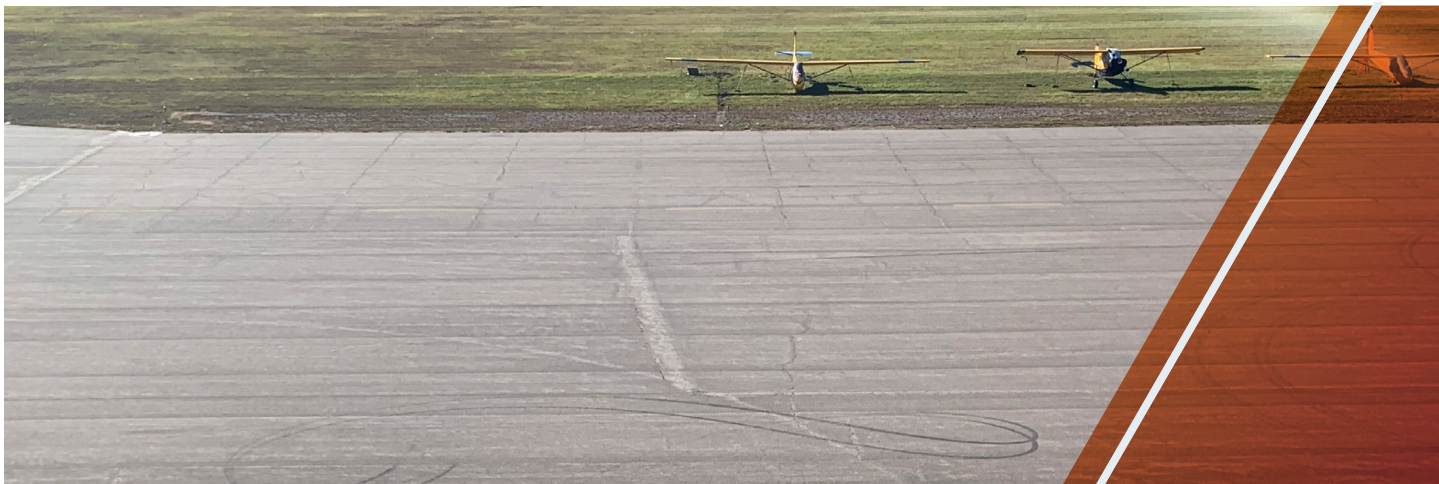
Condition of the Centralia Airport apron 30 years later.

In November of 2022, the site was visited again. After 30 years of enduring harsh Canadian weather, the airport apron had experienced cracking. Dean Pettitt, who is a local engineer familiar with the harsh winters and GlasGrid products commented, “That’s pretty impressive for 30 years considering the original condition.”

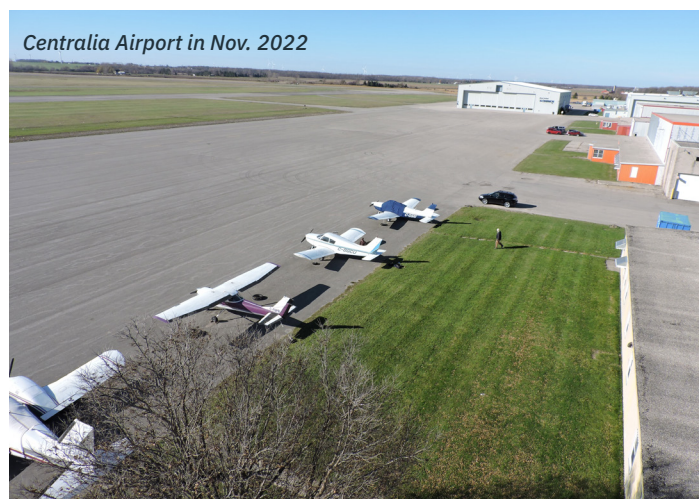
Condition of the airport apron in 2007 after more than 13 years of use.

A return site visit in February 2007 revealed that the GlasGrid System reinforced pavement had experienced only minor cracking after more than 13 years of post-rehabilitation service. Brad Pryde, the design engineer of record on the project stated, "We incorporated GlasGrid 8501 into Centralia Airport's concrete apron rehabilitation to mitigate the reflective cracking that was anticipated to reoccur in
